## **Efflorescence.**

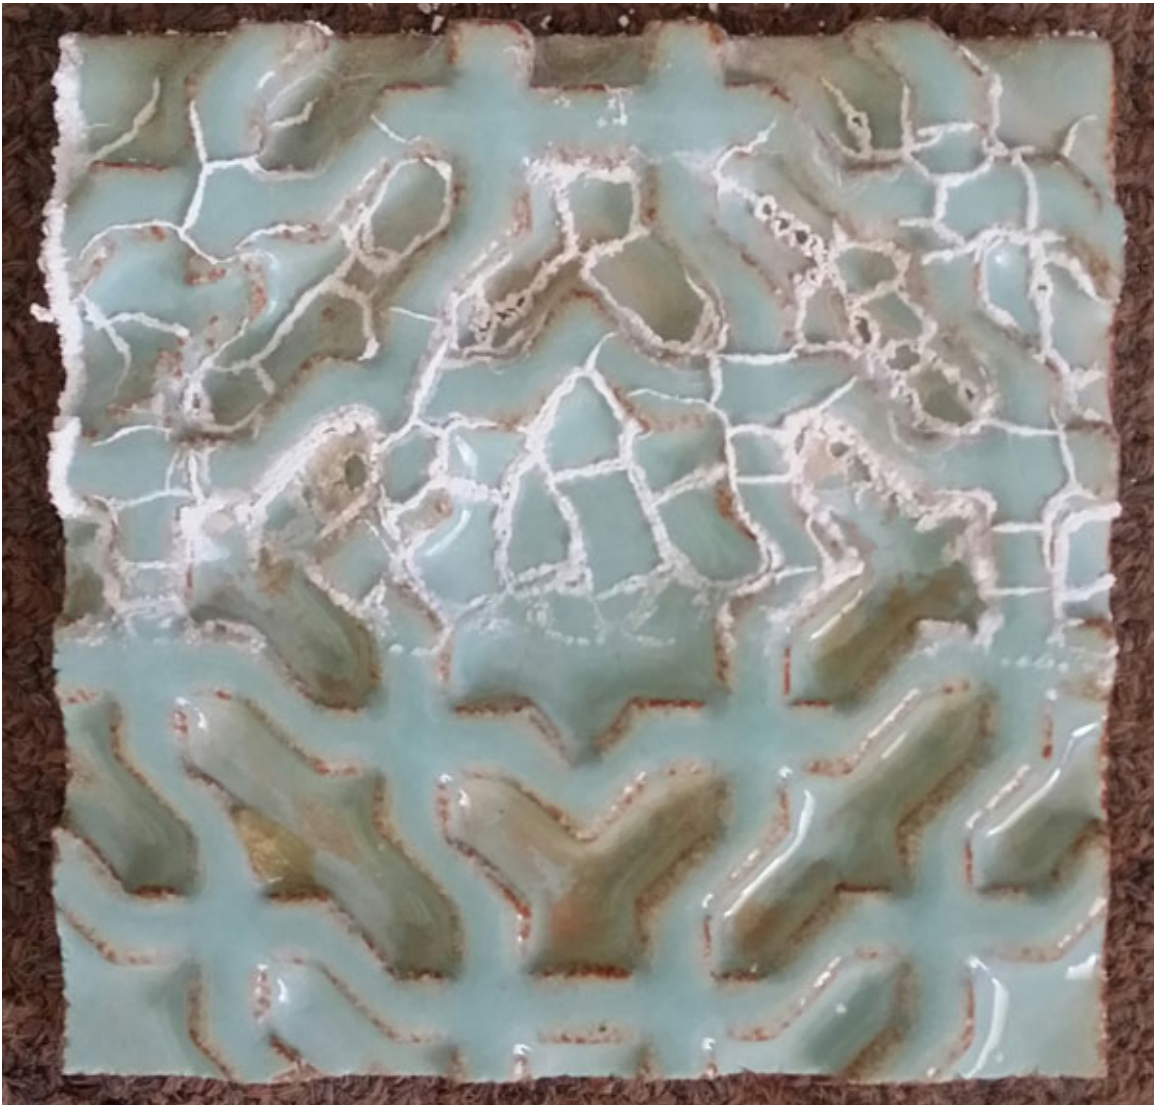
The below pictured tile was soaked in a chlorine solution with the top portion exposed to the air to allow the water to evaporate. Capillary action has brought the dissolved minerals to the surface leaving behind a white residue.

Efflorescence is caused by soluble minerals, such as salts, being present in water that leeches to the surface of tiled areas from beneath them. Once the water that brought the minerals to the surface evaporates it leaves behind a white residue on the surface. More can be read about efflorescence at the following article on line, <https://www.tcnatile.com/faqs/31-efflorescence.html>

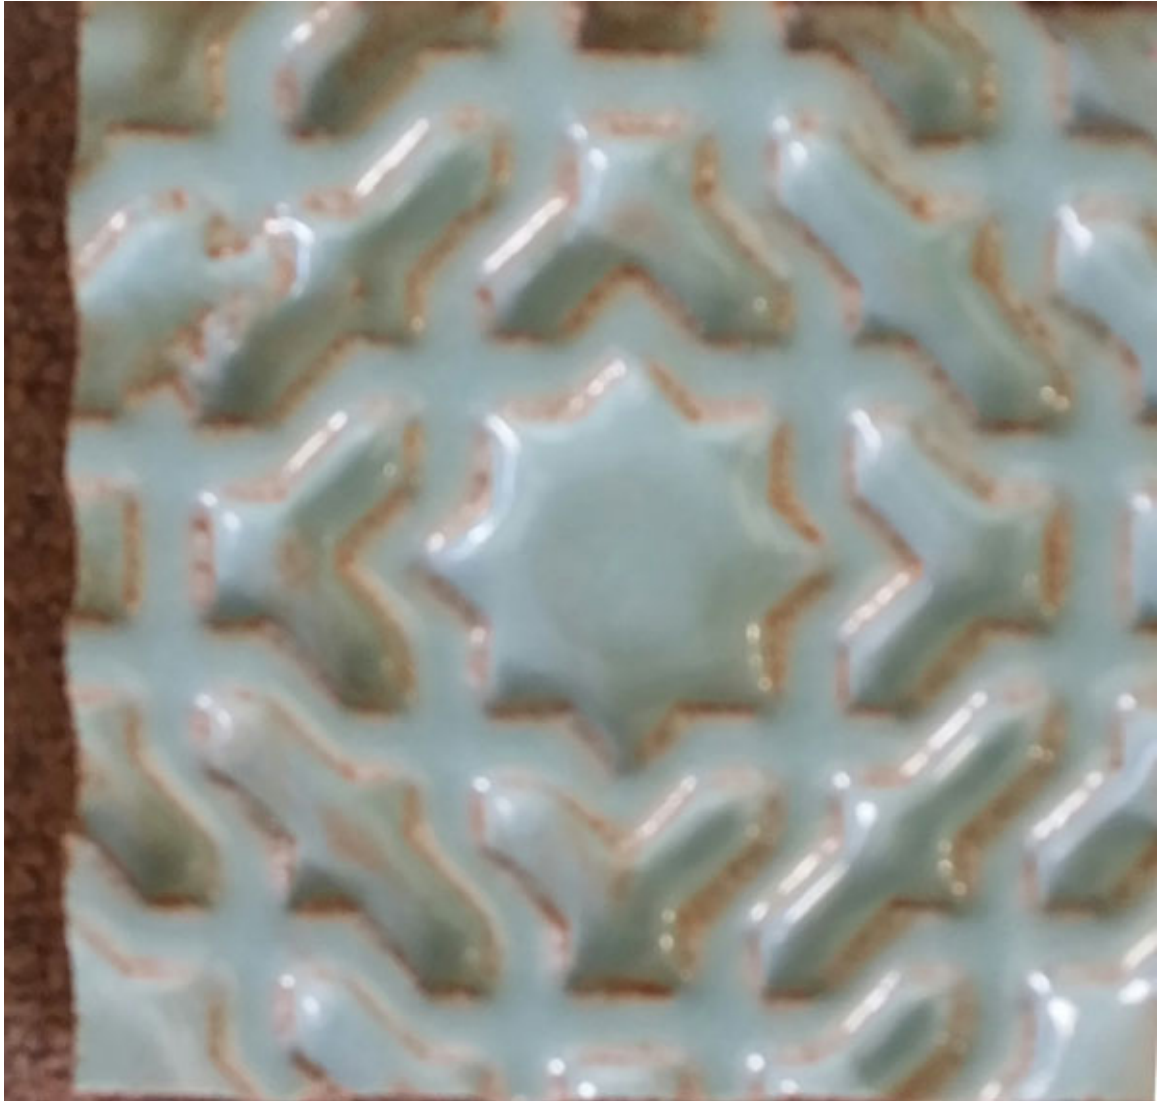
In this case simply wiping the tile down was ample to clean the efflorescence off.
