D&W Ceramics Freeze-Thaw Testing.

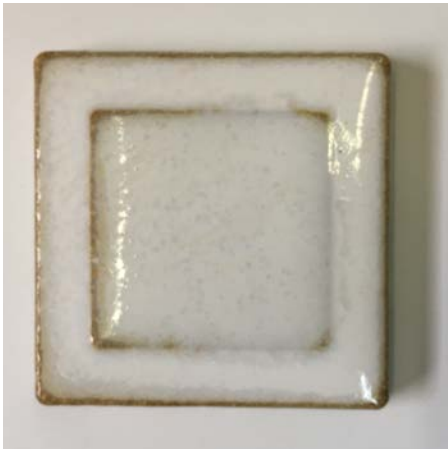
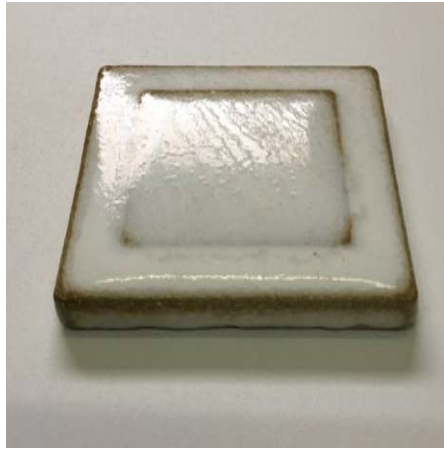
The above D&W Ceramics tile shows no signs of failure after the aforementioned testing. In comparison, the below photographs show tiles from other manufacturers that did fail during our testing

Utilizing the testing method described in ASTM C 1026 standard we scrutinized our product above and beyond, subjecting it to over 100 cycles without seeing any failure. In comparison big box home improvement store tiles we have tested begin to fail at approximately 10-15 cycles. More can be read about this tile testing procedure and freeze thaw testing in the TCNA article entitled "Frost Resistance Equals Freeze-Thaw Testing". This article is available on line at <http://www.tcnatile.com/images/pdfs/Frost%20Resistance%20Equals%20Freeze-Thaw%20Testing.pdf>

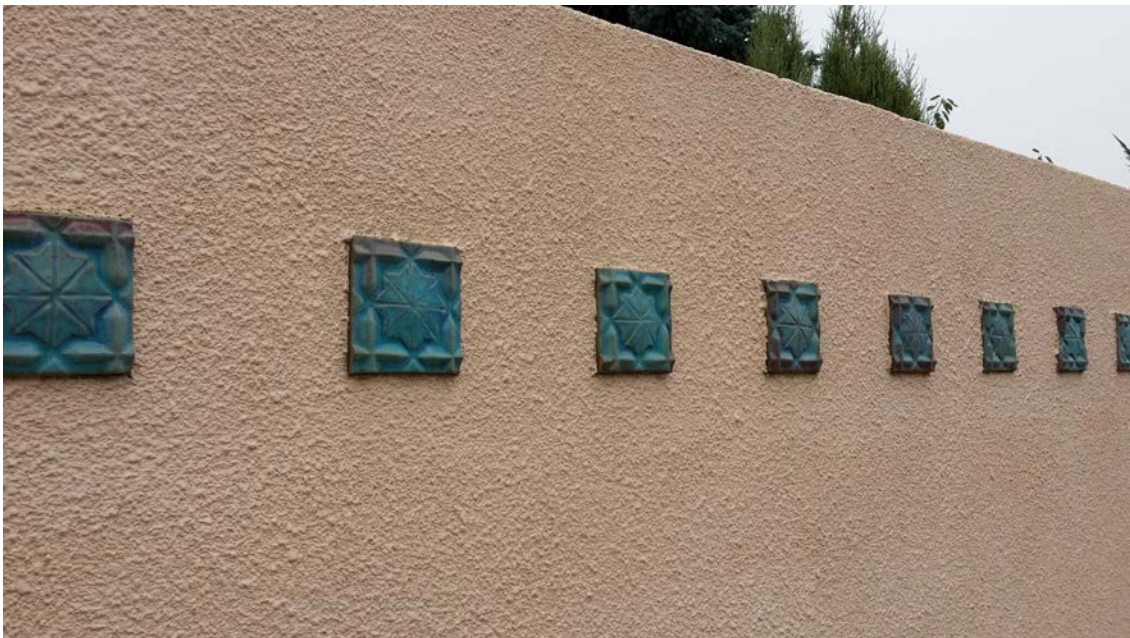
The photograph below is of D&W Ceramics tile that has been installed in an exterior location in the Denver Metro area for over twenty years. As is visible from the photo no failure has occurred with any of these tiles over that time.
